To: All IPS RMR Pressure Testing Personnel

Date: 9/24/2007

Pressure Testing- Air Compressor Valve Replacement

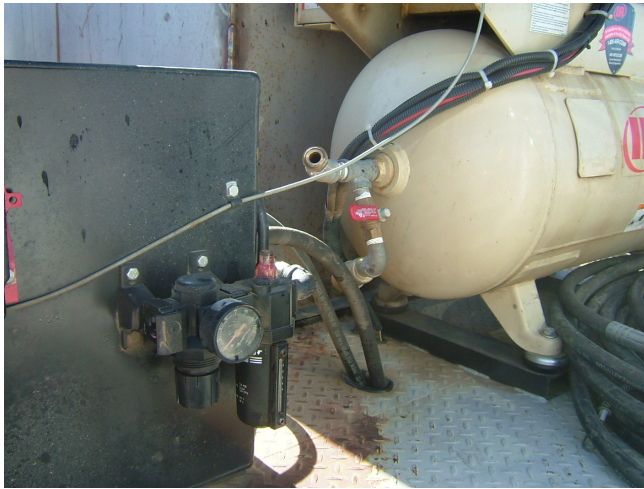
Incident: While on Frac Operations the Pressure Tester had just finished up loosening hatch bolts on production equipment with the pneumatic wrench when the incident occurred. The Tester went over to the truck, turned off the air compressor, and began to bleed off condensation when he heard a loud pressure release. The Tester was struck on the brim of his hardhat, knocking it off and sending it approximately ten feet from his person. A brass 2-piece, 1/2" Isolation ball valve, located coming off the compressor tank had parted at the 2 piece connecting point on the valve with approximately 140 psig on it.

The parted half of the valve was still connected to the section of air hose that runs to the lubricator when striking the Tester's hardhat. The employee was not injured by this incident. He promptly reported the incident to the Company Representative on location and to his Immediate Supervisor.

Findings: Ball valve was rated to 600 psig. Upon inspection the ball valve appeared to have been cracked prior to parting because of oxidization pattern at the break. The valve had been removed from the compressor tank and was reinstalled downstream of a tee assembly. The orientation of the valve, coming off the tee assembly, allowed hose and valve half to fly outward from the side of the truck bed. No whip check was in place at the time of the incident.

- 1. Communicate this incident to all Pressure Testing Personnel by phone and through this Safety Alert and discuss the severity potential during next safety meeting.*

- 2. A thorough inspection is to be performed on all equipment associated with the air compressor system on all pressure testing units.*
- 3. All 2 piece valves used in the compressor air system will be changed out to a 1 piece design as soon as practical. If these are not available as a shelf item locally, please contact Chris Lucas as soon as possible; He has located a source in Riverton.*

- 4. Whip checks will be installed on all air compressor fittings and valves on current test units and on all new construction units in appropriate locations to secure all hoses and fittings as practical.*

- 5. Valves and fittings will be orientated in a manner that will direct pressure and hose ends in a safe direction in the event of a failure, i.e., toward inside of test unit bed, not toward outside of bed where personnel might normally be standing.*

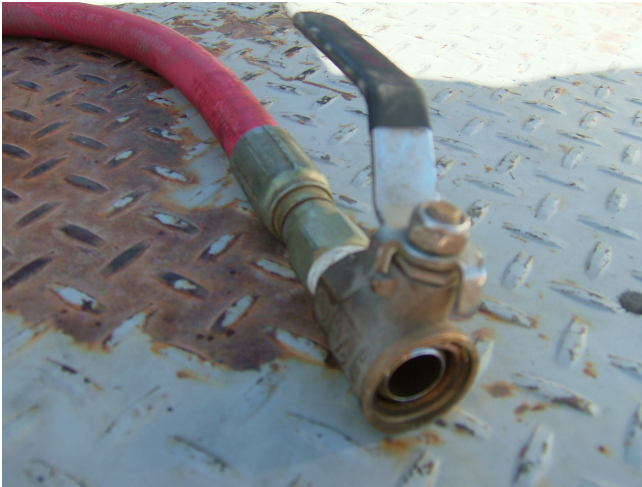
Root Cause: Defective or damaged valve within the air system.

Corrective Actions:
